FSSI - Family Shelter

HAZARDOUS MATERIALS SURVEY REPORT

**RE: Hazardous Materials Survey Report
2300 North Branch Avenue (Building #1)
2304-2306 North Branch Avenue (Building #2)
2310 North Branch Avenue (Building #3)
2313 Beale Avenue (Building #4)
City Of Altoona, Blair County, Pennsylvania**

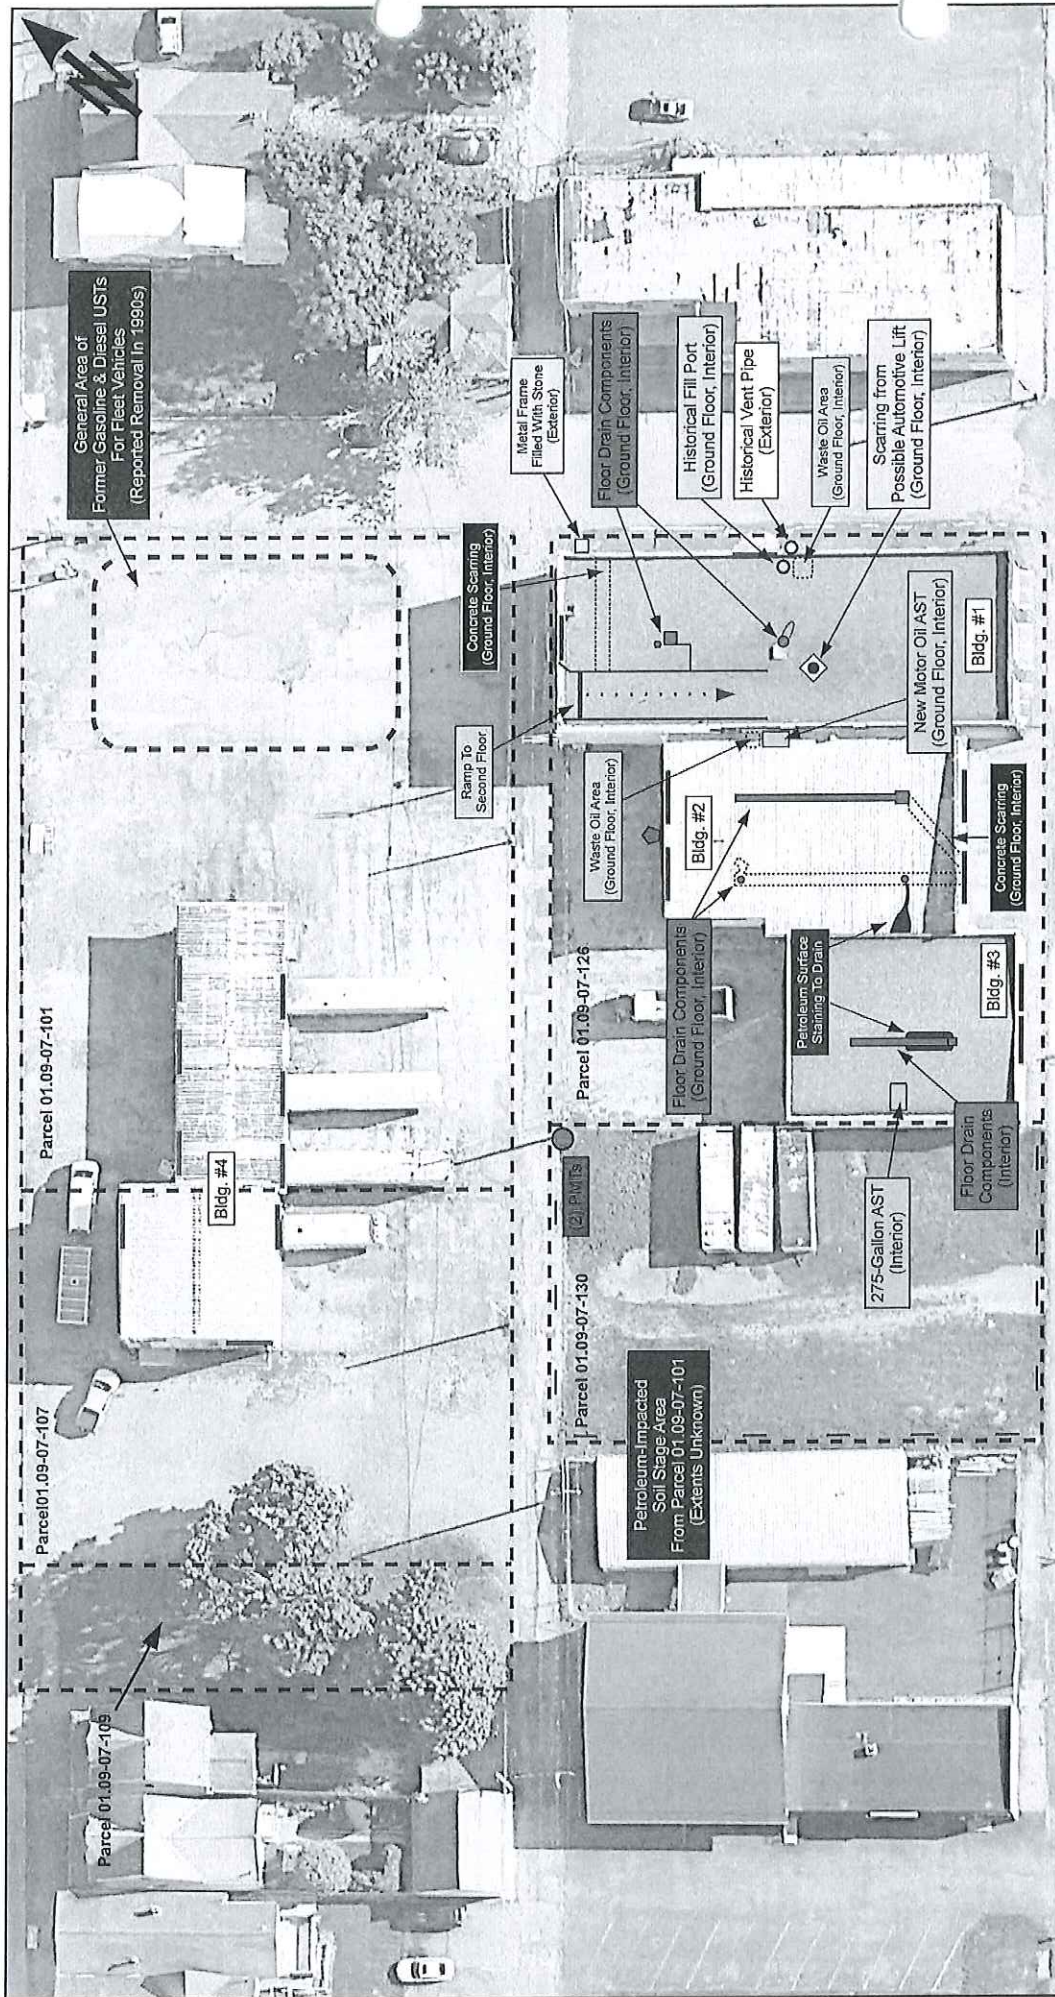
Figure 1

General Area of Former Gasoline & Diesel USTs For Fleet Vehicles (Reported Removal In 1990s)

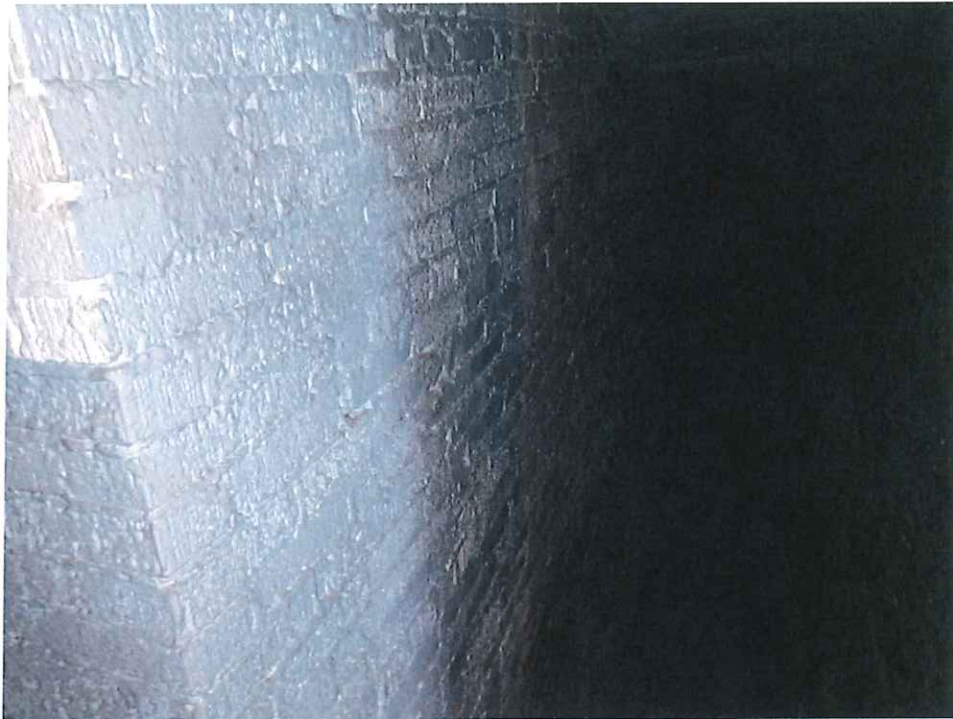
Building #1 – basement stairwell walls (blue/gray paint)

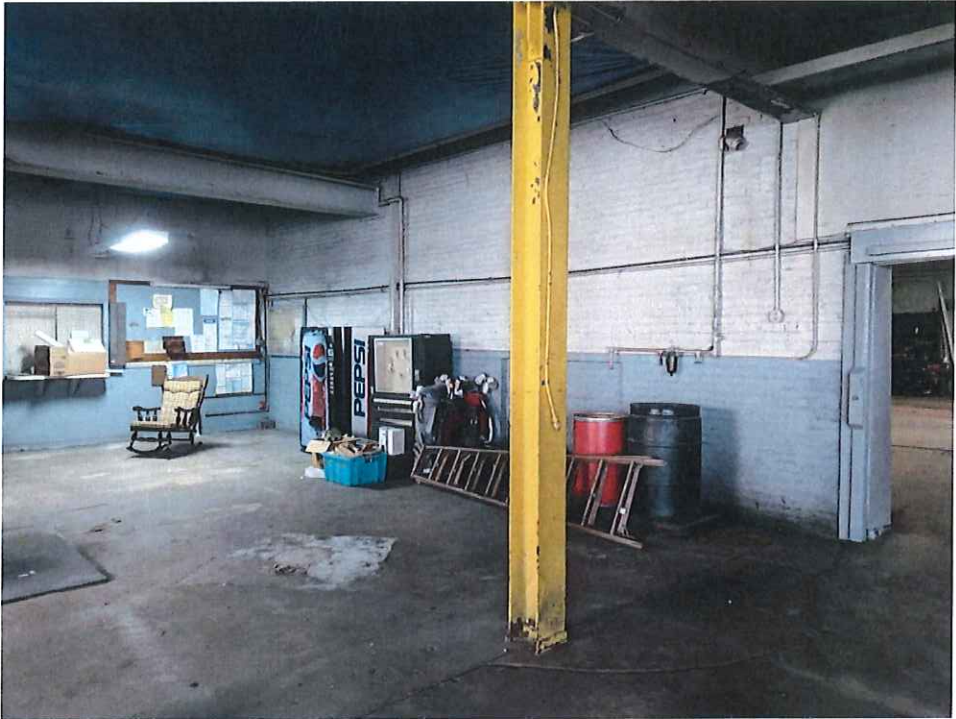
Building #1 – vertical support beam on 1st floor (yellow paint)

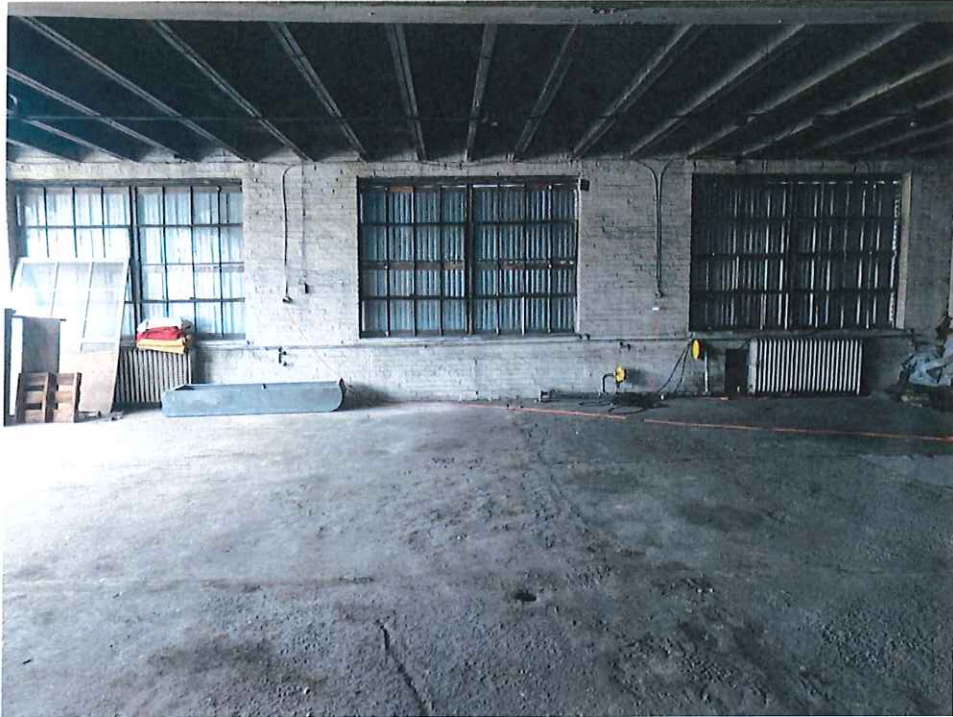
Building #1 – southern interior wall on 2nd floor (white paint)

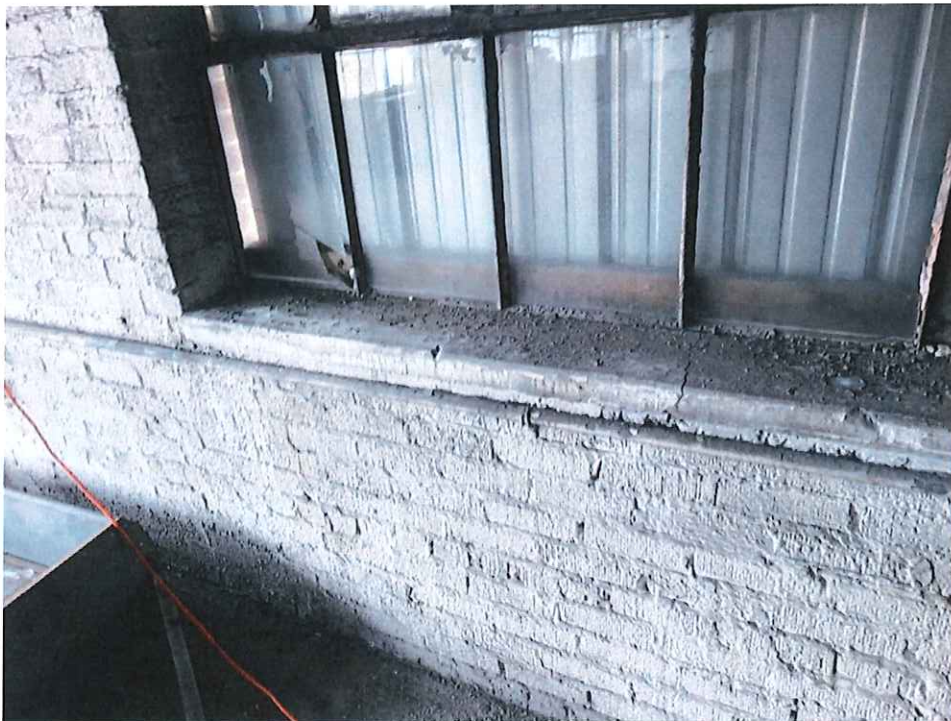
Building #1 – window sills on 2nd floor (white paint)

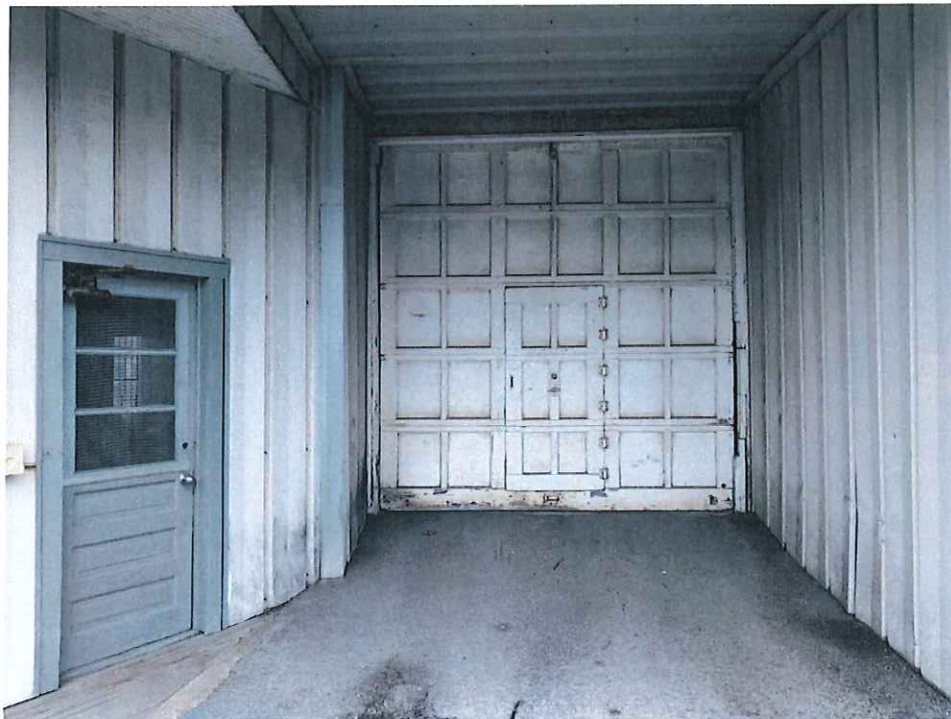
Building #1 – exterior portion of overhead bay door to 2nd floor ramp (white paint)

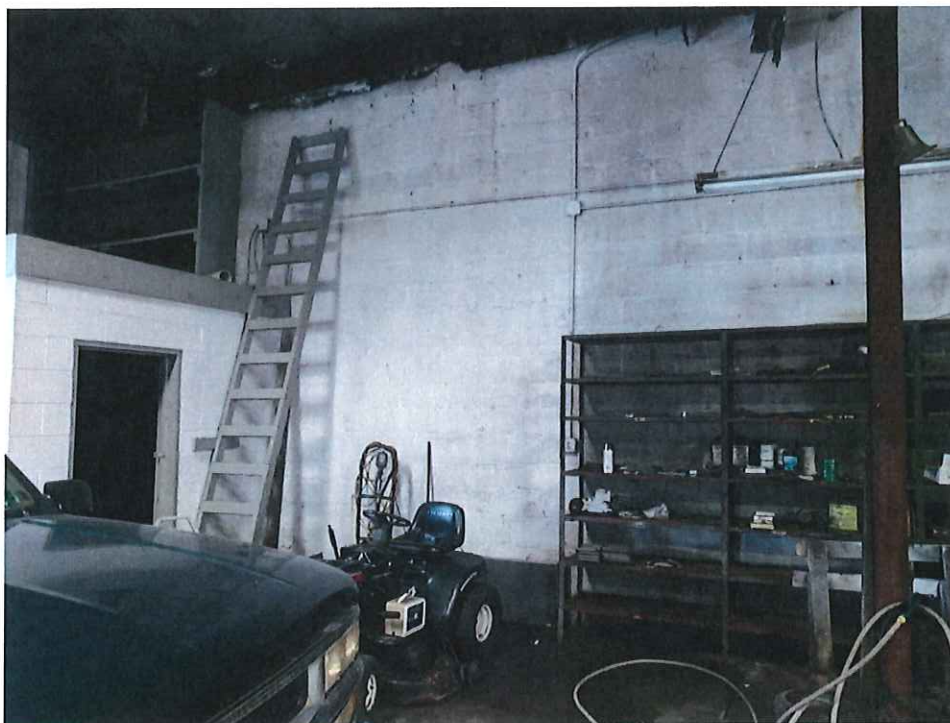
Building #2 – western interior wall (white paint)
